COLUMBIA PARK MASTER PLAN:

Turlock, California

June 2020

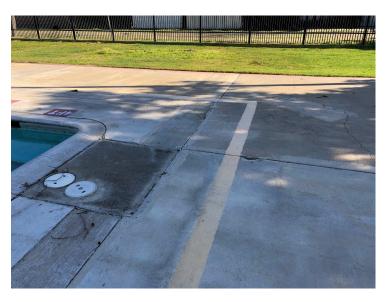
The swimming pool deck is cracked in numerous places and heaving. Uneven deck surfaces create a safety hazard as someone can easily catch a toe and trip. Additionally, the deck does not have any dedicated in-deck drainage. The deck appears to slope towards perimeter landscape as a means of drainage. A lack of adequate drainage can create standing water, which can pose a safety hazard for both slip and fall injury as well as pathogen growth. Staff report that the health department mentions the failing deck during annual inspections. The deck is in violation of Title 24, Chapter 31B:

3114B.3. Deck slope. The pool's deck surface shall have a slope of no less than 1 percent but no more than 2 percent away from the pool to a deck drainage system and shall be constructed and finished to prevent standing water.

Swimming Pool Deck Has Visible Cracks and No In-Deck Drainage

The existing deck is a medium broom concrete finish and the new deck shall be a medium broom concrete finish with new deck drains and ADA compliant slopes of no less than 1 percent and no greater than 2 percent. Required deck depth markers and "no diving" markers indicated in section 1.4 should be added during deck replacement. The following cost estimate includes demo of the existing deck, new medium broom finish concrete decks, new deck anchors, new depth and safety markers, new deck drains, and a new in-deck drainage system. If a connection for an in-deck drainage system cannot be easily made to a nearby storm drain sufficient to handle the capacity of incidental swimming pool and rain water the cost will increase.

(Estimated Cost \$458,100.00)

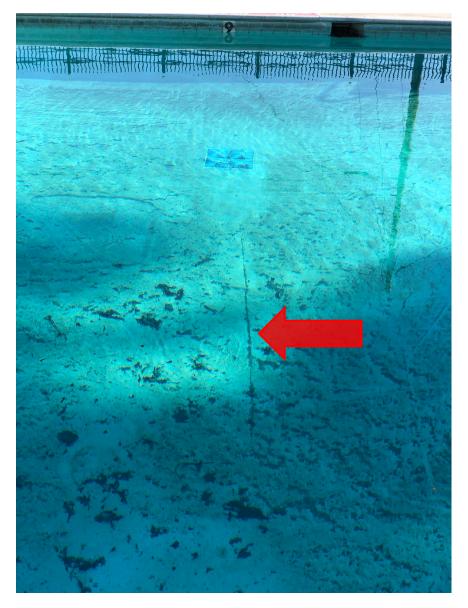
The surface of the swimming pool is showing signs of age. Staff report the surface was last replaced in 1999. The National Plasterers Association states that swimming pool plaster should be expected to last between 12-15 years under normal conditions. In several locations the swimming pool surface has delaminated, spalled, or otherwise separated. This results in unsafe conditions on the surface where sharp edges exist which could result in feet, hands, or other skin being cut or torn when in contact with the surface. The current porous plaster finishes could harbor pathogen growth, creating a further health and safety concern. Lastly, the state of the current plaster may create a condition where water is closer to the underlying structure of the swimming pool shell and could result in further oxidation and deterioration of the steel rebar which can increase the risk of leaks and structural failure of the pool shell. The plaster finish on the swimming pool is in violation of Title 24, Chapter 31B:

Linear Crack in Plaster Finish

The pool finish should be replaced. The industry standard is to use a quartz-based plaster and tile to finish the pool. The following estimate includes removal of all existing previous pool finish to bare concrete and the installation of a new plaster and tile finish. This estimate also assumes the underlying bare concrete is in good condition and does not need replacing.

(Estimated Cost \$354,500.00)

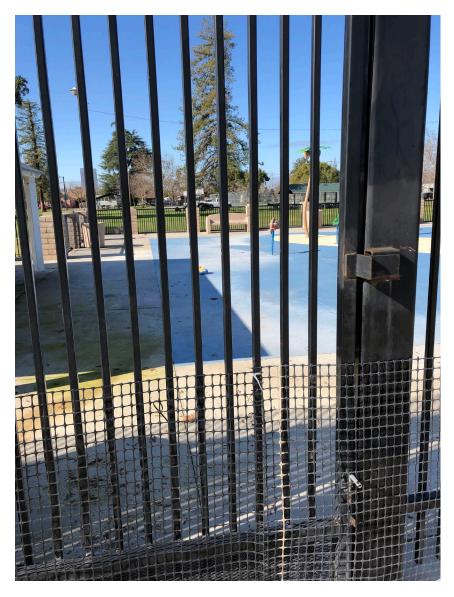
The perimeter fence for the facility is a tubular steel fence that staff report was last replaced in 2005. The current gates for the fence do not have self-closing and self-latching devices and open towards the swimming pool instead of away from the swimming pool. The gates are therefore in violation of Title 24, Chapter, 31B:

Gate on Swimming Pool Perimeter Fencing

The lack of self-closing and self-latching devices and the opening direction of the gates poses a safety risk. The gates should be updated to open away from the swimming pool and be fitted with self-closing and self-latching devices. The following estimate is for three (3) new gates to meet Title 24 enclosure and gate requirements.

(Estimated Cost \$45,000.00)

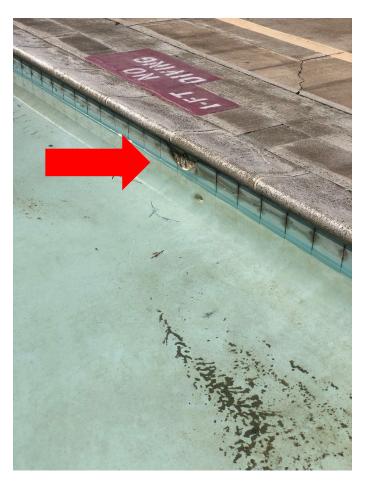
Waterline tile on the swimming pool is cracked, chipped, and missing in numerous places. The sharp edges pose a potential safety hazard. Staff report the health department mentions the failing tile during annual inspections and expresses that the swimming pool could be forced to close as a result of the failing tile. The broken waterline tile is in violation of Title 22, 116043:

Furthermore, the waterline tile is heavily stained by both water and organic materials. Even with a diligent cleaning the waterline tile would look unsanitary. All waterline tile is beyond its useful lifecycle and should be replaced. The tile work would best be completed during installation of a new pool surface (see section 1.3). As such, the estimate for tile work is included in section 1.3.

Chipped / Missing Swimming Pool Waterline Tile

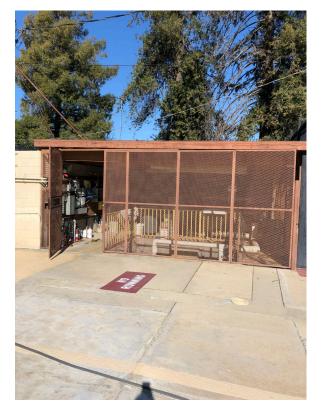
The mechanical enclosure houses calcium hypochlorite and muriatic acid. Calcium hypochlorite is classified as a class 3 oxidizer and a reactive substance. It is also classified as both a health hazard and a physical hazard and has the ability to support a fire. There is no placard sign on the door to the mechanical enclosure warning of the presence of calcium hypochlorite. Muriatic acid is classified as a class 2 corrosive and a health hazard. There is no placard sign on the door to the mechanical enclosure warning of the presence of muriatic acid. The lack of signage is in violation of Title 24, Part 9:

5003.5 Hazard identification signs. Unless otherwise exempted by the fire code official, visible hazard identification signs as specified in NFPA 704 for the specific material contained shall be placed on stationary containers and above-ground tanks and at entrances to locations where hazardous materials are stored, dispensed, used or handled in quantities requiring a permit and at specific entrances and locations designated by the fire code official.

Swimming Pool Mechanical Enclosure

The required signage should be purchased and installed. The following estimate is for signage.

(Estimated Cost \$1,000.00)

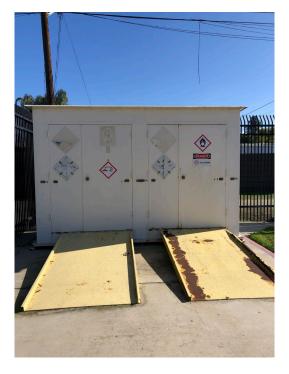
The chemical storage areas house calcium hypochlorite (briquettes) and muriatic acid (jugs). As noted in section 1.9, both chemicals are hazardous and require signage to communicate the hazards that these chemicals pose. There are no placard signs on the doors to the chemical storage areas warning of the presence of calcium hypochlorite and muriatic acid. The lack of signage is in violation of Title 24, Part 9:

5003.5 Hazard identification signs. Unless otherwise exempted by the fire code official, visible hazard identification signs as specified in NFPA 704 for the specific material contained shall be placed on stationary containers and above-ground tanks and at entrances to locations where hazardous materials are stored, dispensed, used or handled in quantities requiring a permit and at specific entrances and locations designated by the fire code official.

Chemical Storage Areas on Pool Deck

The required signage should be purchased and installed. In addition to signage, double containment is required for muriatic acid and recommended for calcium hypochlorite tablets. Aquatic Design Group could not verify the existence of double containment in the chemical storage areas as access was not provided during the site visit. Double containment for muriatic acid was verified in the mechanical enclosure. Furthermore, cohabitation of acid and chlorine is dangerous and not recommended. The two chemicals can mix and create mustard gas, which is a highly toxic gas that can cause injury and death. Separation of chemicals themselves and separation of chemicals from mechanical equipment will be covered in sections 2.1 and 2.2 in further detail. The following estimate is for signage.

(Estimated Cost \$1,000.00)

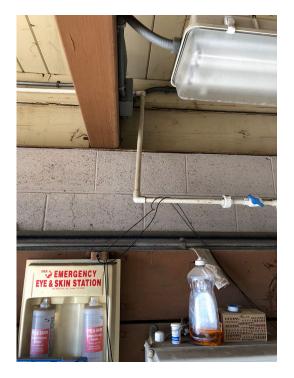
The mechanical enclosure, which houses muriatic acid and calcium hypochlorite, lacks an emergency eyewash shower station. An emergency eye wash is present, however it is a portable unit with finite water. OSHA standards require an emergency eyewash shower station for facilities and employers whose staff come into contact with hazardous chemicals on a regular basis or during a foreseeable accident. Such stations are to be located via a clear path within 10 seconds of the area (typically considered within a maximum of 55-feet). Should it not be possible to install a station inside the enclosure one can be installed directly outside the enclosure. The chemical storage areas also need appropriate access to an emergency eyewash shower station. The chemical storage areas may have a portable eyewash unit but Aquatic Design Group could not verify as access was not provided during the site visit. As stated before though, any eyewash unit the chemical storage areas likely have is not sufficient to satisfy OSHA requirements and provide an appropriate level of safety to staff who handle hazardous chemicals. The following estimate is for an emergency eyewash shower station plumbed to a potable water source.

Emergency Eye Wash in Mechanical Enclosure

(Estimated Cost \$4,000.00)

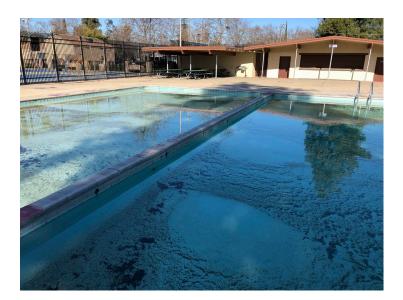
The swimming pool has a dividing wall within the confines of the pool separating the 1'-0" depth area from the rest of the pool (depths that range from 3'-0" to 9'-0"). The purpose of this wall is to create a wading pool for young swimmers. The top surface of the wall is very narrow and poses a risk for physical injury as patrons could easily fall into shallow water while walking across the top of the wall. The wall is considered a projection and is in violation of Title 24, Chapter 31B:

In addition to the above violation of code and risk for injury, the projection can be considered a perimeter end of pool and when qualified as such it must be a minimum of 4-feet wide. The projection is in violation of Title 24, Chapter 31B:

Wall Within Swimming Pool

If a wading pool is not desired, the wall could be removed and the floors resloped to be code-compliant. Removal of the wall and pool floor resloping would best be done during a pool surface and deck replacement project.

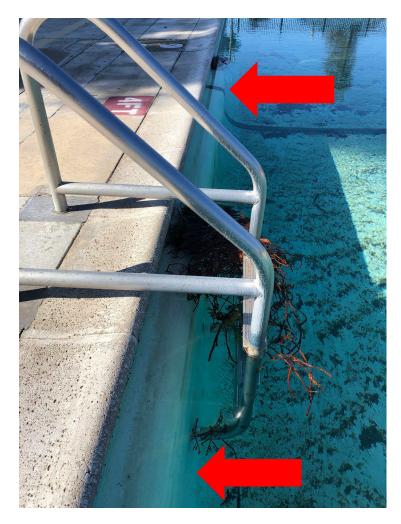
The swimming pool has an additional projection in violation of Title 24, Chapter 31B Section 3108B.4. There is a projection running the length of the south pool wall in the 3'-0" to 4'-0" depth range. The projection poses a risk for injury, particularly as patrons enter and exit the swimming pool in that area.

Projection on South Wall of Swimming Pool

If the deck and pool surface are replaced it is highly unlikely the Health Department will allow the swimming pool to operate with projections that are direct violations of code. These projections are likely being allowed as grandfathered exemptions and the risk of injury remains despite the exemptions. Further clarification could be provided by speaking directly with the health inspector. After review of this draft by the City of Turlock, Aquatic Design Group can update this section of the report with the City's preferred means of addressing this violation complete with a cost estimate.

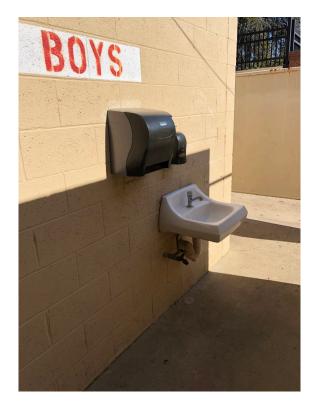
Staff report the restroom facilities were renovated in 2005. They are showing signs of age. In addition to age, the restrooms are not fully enclosed. No roofs exist to provide patrons with both privacy protection and protection from the elements. A renovation is recommended to achieve proper restroom fixture counts, improve patron privacy, and bring new life to an aging part of the facility. If additional bathers from the sprayground utilize the restrooms at the swimming pool a higher load is placed on the fixtures. The sprayground has a system which discharges water to waste rather than recirculates water. Due to this fact the sprayground does not have to follow California Building Code for fixture counts or follow Health Department regulations. It is advised however, to be able to absorb the load on restrooms appropriately as a service to users. Using California Building Code requirements as a guide, an approximately 2,912 square foot sprayground would add 194 bathers. 194 bathers would dictate the following fixtures:

Men's Lavatory

The City of Turlock may weigh the decision to increase the fixture count beyond the required number for the swimming pool. Any restroom fixtures serving to satisfy code requirements for the swimming pool must be within 300 feet of the swimming pool.

Other restroom facilities are located in the park which can accommodate sprayground users, they are just not located in as close proximity as the pool restrooms are to the sprayground. After review of this draft by the City of Turlock, Aquatic Design Group can update this section of the report with the City's preferred means of addressing this violation complete with a cost estimate.

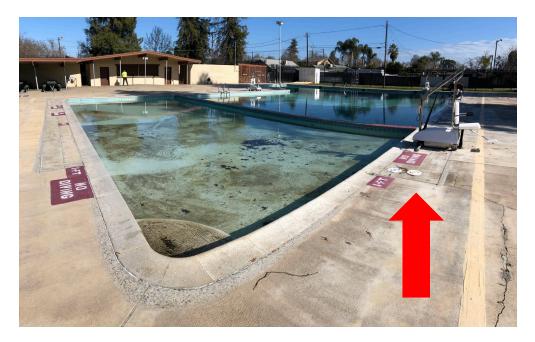
The swimming pool has three battery-operated ADA lifts, which more than satisfies the code required number of lifts. Although a lift is installed in the 1-foot deep area of the swimming pool, due to the pool depth in that area it is in violation of CBC Section 1141A:

- 6. Be positioned so that, if the pool has water of different depths, it will place the operator into water that is at least 3 feet deep.
- 7. Be capable of lowering the operator at least 18 inches below the surface of the water.

ADA Lift in 1-Foot Deep Area of Swimming Pool

The pool would need to be modified in a renovation project to provide accessibility to that area. If the wall did not exist there would already be accessibility to that area by way of the two other ADA lifts that are attached to the pool deck. Removing the dividing wall in the swimming pool and resloping the pool floors would be the best solution to eliminate the need for a third ADA lift. As noted in section 1.14, a renovation of this kind would best be done during a pool surface and deck replacement project. Also noted in section 1.14, the Health Department would likely request the wall be removed during a pool surface and deck replacement project. Further clarification could be provided by speaking directly with the health inspector. After review of this draft by the City of Turlock, Aquatic Design Group can update this section of the report with the City's preferred means of addressing this violation complete with a cost estimate.

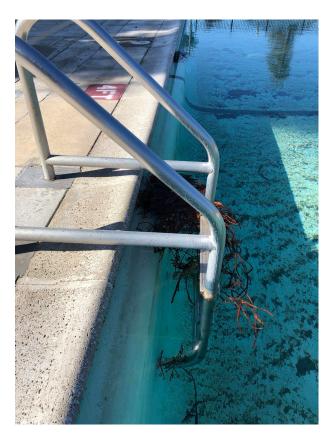
At least one of the ladders has a clearance distance of less than 3 inches at the rounded bottom portion of the ladder. All ladders have steps with clearance distances greater than 5 inches. Code-compliant ladders should be installed. If the pool surface was renovated, recessed steps could be constructed. Modifications to the deck would be required to properly install new ladders. Ladder installation would best be done during a deck replacement project. The following estimate is for replacement ladders that comply with code.

Ladder with More than 12 Inches of Clearance From Swimming Pool Wall

(Estimated Cost- \$4,400.00)

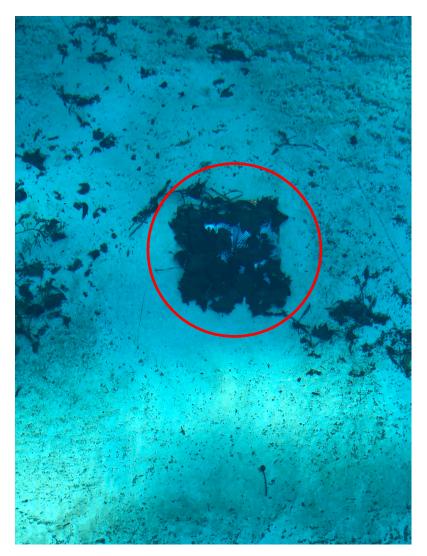
No as-built drawings for under pool piping were provided. Staff report that main drain grates were replaced in 2009 and then recalled in 2011. Staff also report that main drains are currently out of compliance. It is unclear whether this is related to drain cover expiration, incorrect drain cover equipment, or under pool piping being out of compliance. Based on the age of the swimming pool and the information provided about minor renovations it is likely that main drain interior sump dimensions are not in compliance. Further investigation would be required to identify issues and possible resolutions.

Main Drain for Swimming Pool

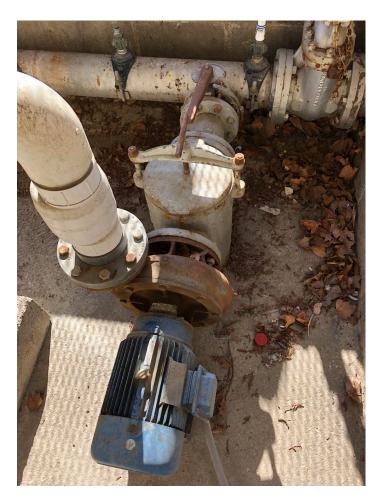
One circulation pump and motor was replaced in 2013. Without gallons per minute information for the specific pumps and motors as well as piping plans it is difficult to assess whether the circulation system is keeping up with demand or meeting code compliant standards for turnover rate. Staff report no water quality issues. Even with limited information the circulation pumps and motors are well beyond their useful lifecycles, as are the pump strainers and circulation piping and piping components. An overhaul of the system is recommended. The following estimate is for new circulation system equipment and is listed as a range because of unknown information about pool piping.

One of Two Swimming Pool Pumps, Motors, and Strainers

(Estimated Cost- \$30,000.00 - \$80,000.00)

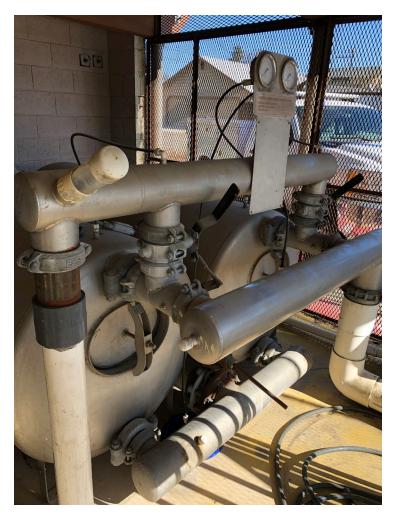
The sand filters were replaced in 1994. They are stainless steel Hydrokleen filters. Gallons per minute and filter surface area are unknown to Aquatic Design Group. Swimming pool filter tanks usually last about 20 years. The Hydrokleen filters are well beyond their lifecycle and staff report an inability to find replacement parts. As a result, staff fabricate their own parts for repair of the existing filter tanks. A new filter tank system and related piping is recommended. The following estimate is for a new high rate sand corrosion resistant filter tank system.

Swimming Pool Filter Tank System

(Estimated Cost- \$120,000.00)

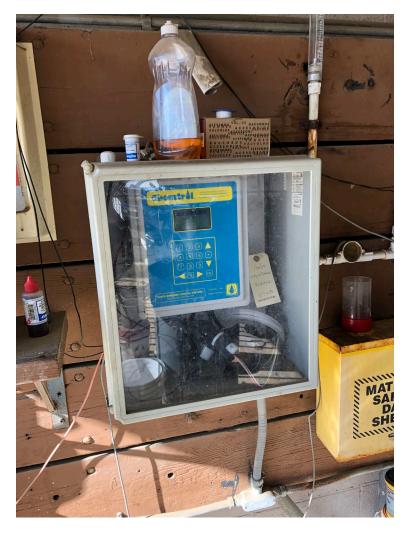
The chemical controller was replaced in 2000. Staff report that it functions well but acknowledge it has no modern capabilities such as data logging, safety features, and remote monitoring. Installing a modern chemical controller as part of a complete mechanical room renovation is recommended. The following estimate is for a new chemical controller.

Swimming Pool Chemical Controller

(Estimated Cost- \$25,000.00)

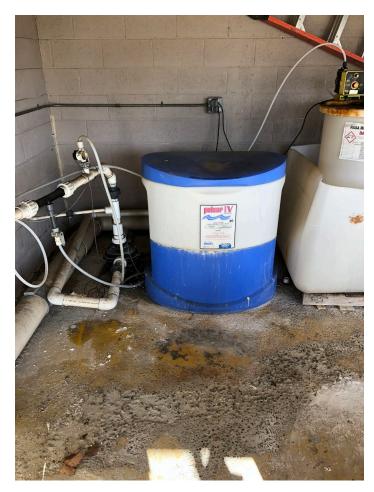
Reloading a tablet chlorine system is both a labor and time intensive process. Buckets of tablets have to be lifted and poured into the system. Even with safe handling practices risks are still present, especially with current conditions of cohabitation and a lack of a proper emergency eyewash shower station. In addition, the tablets themselves have to be stored on site. A recommended replacement disinfection system (chlorine) would be a bulk liquid sodium hypochlorite tank and automated feed system located in its own chemical room. Chlorine delivery would be done by a 3rd party bulk chemical delivery company and the system would be automated and controlled by the chemical controller. This suggested system, like the suggested pH and alkalinity systems, reduces the handling of and exposure to hazardous chemicals for staff.

Chlorine System in Mechanical Enclosure

The following estimates are for bulk tank and delivery systems. Estimated costs for construction of chemical rooms is excluded.

(Bulk Acid and Carbon Dioxide Systems Estimated Cost- \$30,000.00) (Bulk Chlorine System Estimated Cost- \$20,000.00)

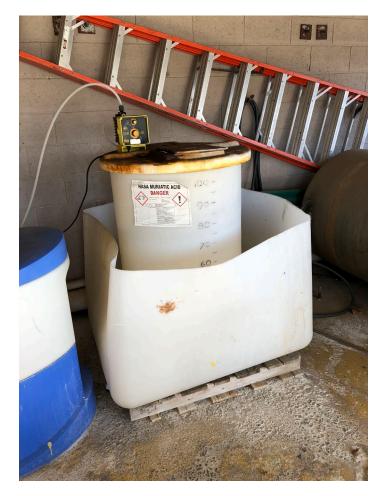
Acid System in Mechanical Enclosure

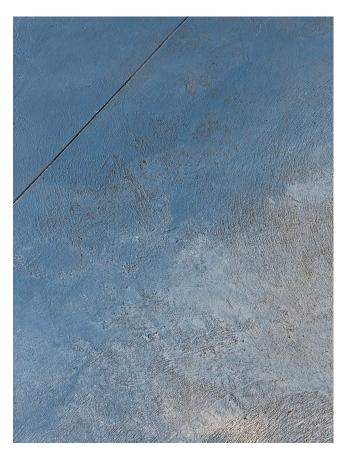
The existing sprayground deck color has faded and the surface itself is becoming slick and slippery in many areas. Resurfacing the sprayground in the near future is recommended to improve safety and bring new life to the sprayground. There are many resurfacing options available including completely removing the existing deck and replacing it with new concrete, scarifying the existing deck and applying a new top coat, or scarifying and adding a new surface on top of the existing deck. New surfaces such as LifeFloor are gaining popularity in the industry because they excel at slip resistance, chemical resistance, cleanability, impact attenuation, UV stability, and impermeability in sprayground environments. After review of this draft by the City of Turlock, Aquatic Design Group can update this section of the report with the City's preferred means of addressing this maintenance item complete with a cost estimate.

Existing Sprayground Surface

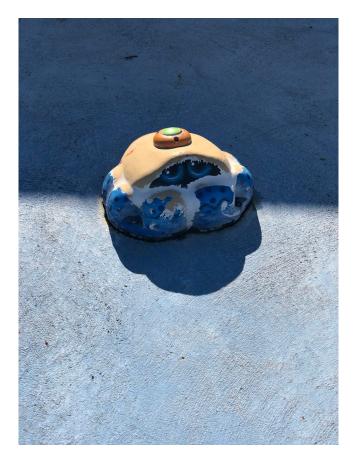
The existing sprayground features are faded and could be revitalized by adding a new coat of paint. Most manufacturers recommend repainting features every 3-5 years. Costs can range depending on chosen method and materials. The following estimate is for repainting of sprayground features and is listed as a range to reflect the cost variance for chosen method and materials.

Faded Sprayground Feature

(Estimated Cost- \$10,000.00 - \$20,000.00)

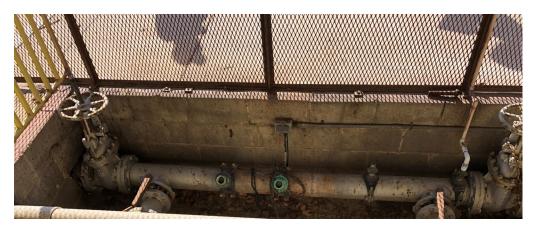
Piping for the swimming pool in the mechanical enclosure is a mix of materials that include: PVC, stainless steel, and steel. The steel piping, including the cast-iron piping, is rusting and corroding. With time the steel piping and connections will fail. Additionally, as the steel piping corrodes dissolved metal goes into the pool water and stains the pool surface. All steel piping should be replaced. Aquatic Design Group recommends schedule 40 PVC below grade and schedule 80 PVC above grade. An estimated cost for replacement piping is included in section 2.1 as piping would be replaced in concert with mechanical equipment replacement to ensure proper piping selections and pipe sizing.

Steel Piping Corroding and Rusting
